NACA RM E50C15

EFFECTS OF INLET ICING ON PERFORMANCE OF AXIAL-FLOW
TURBOJET ENGINE IN NATURAL ICING CONDITIONS

By Loren W. Acker and Kenneth S. Kleinknecht

Lewis Flight Propulsion Laboratory
Cleveland, Ohio

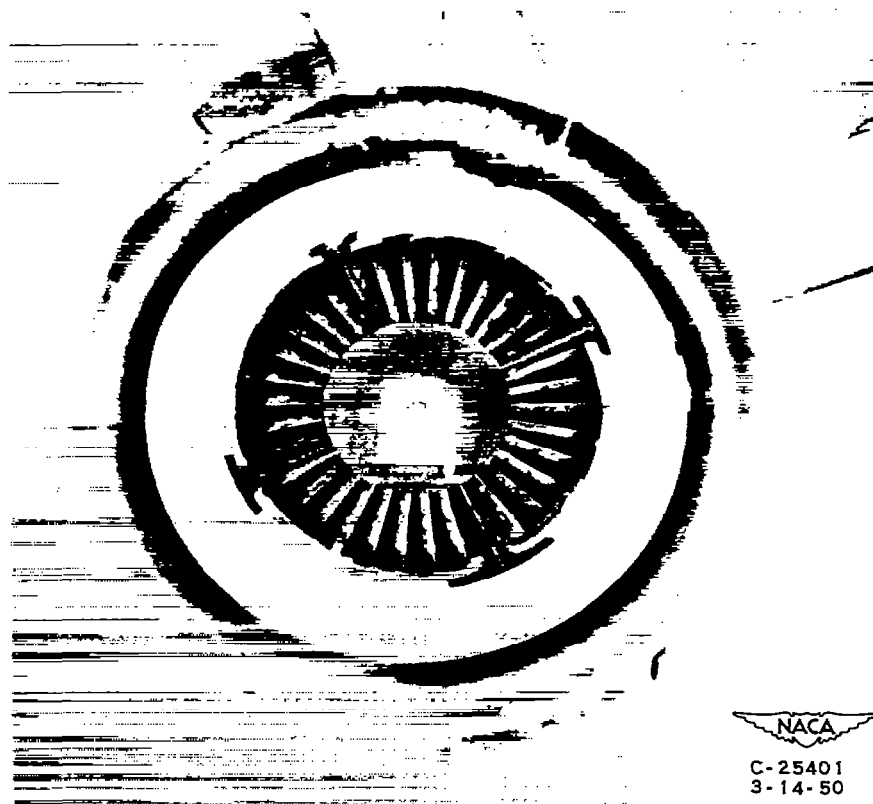
A photograph of the engine inlet, taken approximately 25 minutes after encountering icing during flight 1, is shown in figure 5. A very light ice formation is shown on the guide vanes and no ice is visible on the first stages of the compressor stator blades. Other parts of the engine inlet contained practically no ice because of the electric heating applied to these components.

Figure 5. - Ice formation on compressor-inlet guide vanes during flight 1. Time in icing, 25 minutes; liquid-water content, 0.1 to 0.2 gram per cubic meter; droplet size, 12 to 7 microns; ambient-air temperature, 13° to 16° F; loss in thrust, 6 percent.

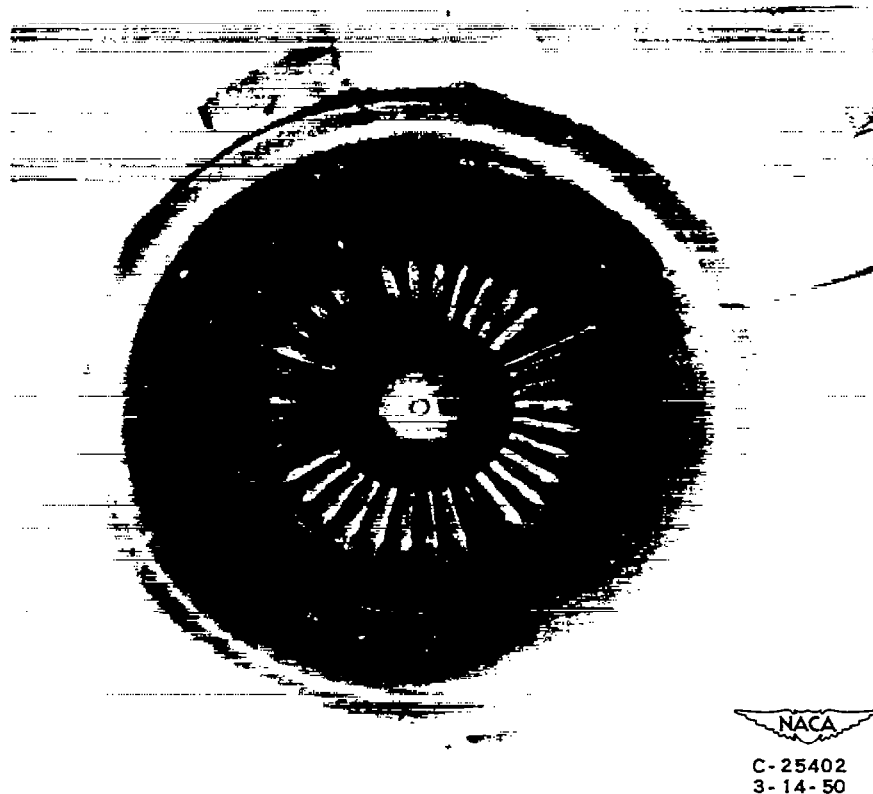
(a) Elapsed time in icing conditions, 11 minutes.

The series of photographs taken during the two parts of flight 2 are shown in figures 7 and 8, respectively. The time intervals at which the photographs were taken are indicated for convenience in figure 6. Photographs from the first part of the flight (fig. 7) show the progress of the guide-vane ice formations from 11 to 35 minutes after the icing condition was encountered.

Figure 7. - Ice formation on compressor-inlet guide vanes during flight 2, with anti-icing. Liquid-water content, 0.3 to 0.5 gram per cubic meter; droplet size, 11 to 17 microns; ambient-air temperature, 22° to 25° F; thrust loss, 8 percent.

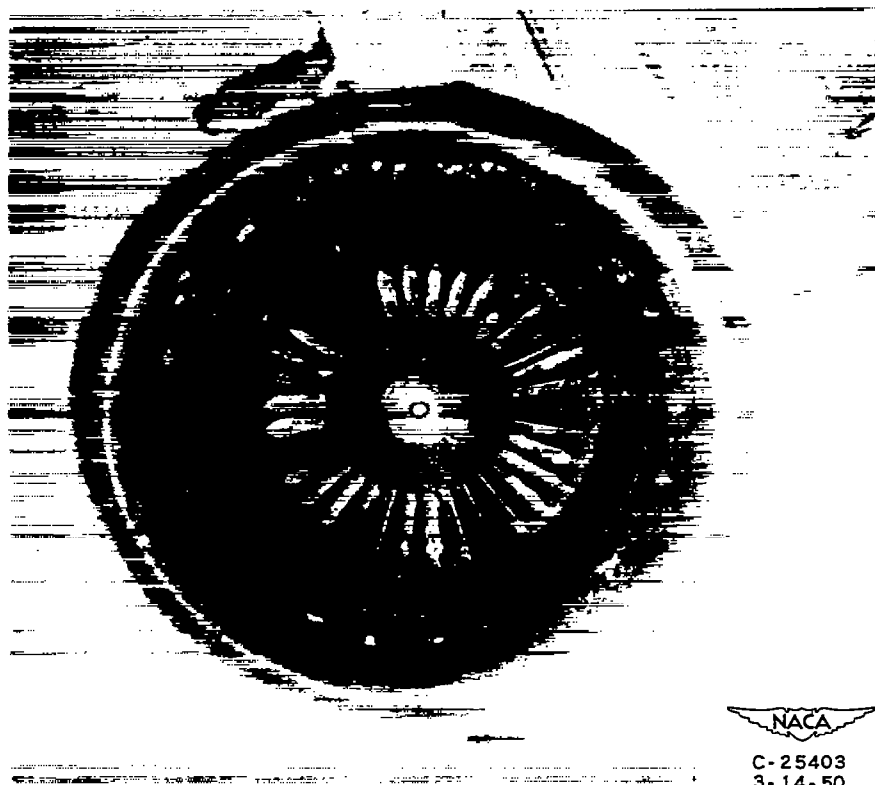
(b) Elapsed time in icing conditions, 17 minutes.

Figure 7. - Continued. Ice formation on compressor-inlet guide vanes during flight 2, with anti-icing. Liquid-water content, 0.3 to 0.5 gram per cubic meter; droplet size, 11 to 17 microns; ambient-air temperature, 22° to 25° F; thrust loss, 8 percent.

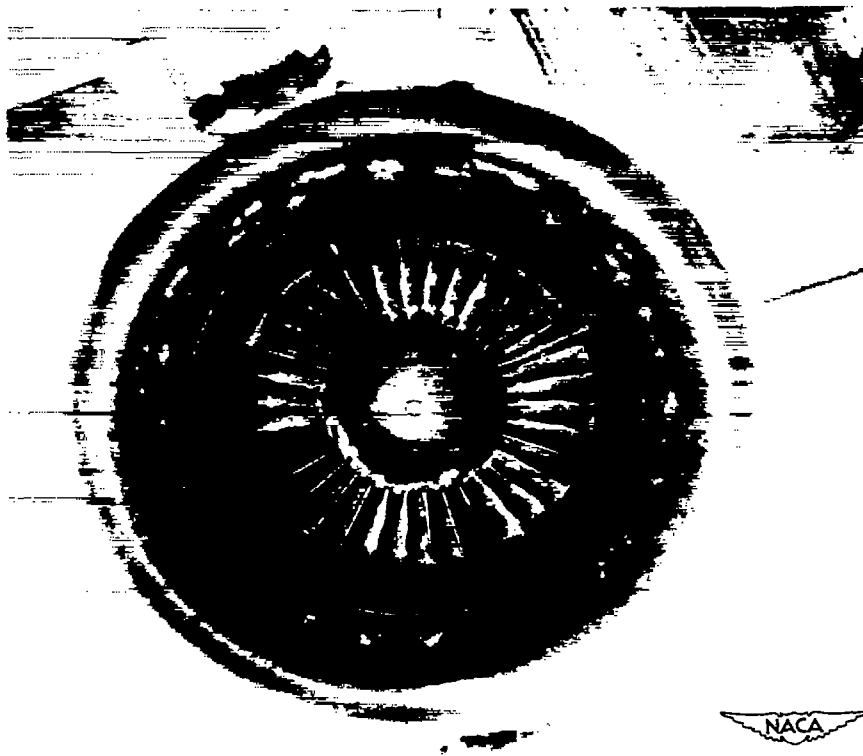
(c) Elapsed time in icing conditions, 24 minutes.

Figure 7. - Continued. Ice formation on compressor-inlet guide vanes during flight 2, with anti-icing. Liquid-water content, 0.3 to 0.5 gram per cubic meter; droplet size, 11 to 17 microns; ambient-air temperature, 22° to 25° F; thrust loss, 8 percent.

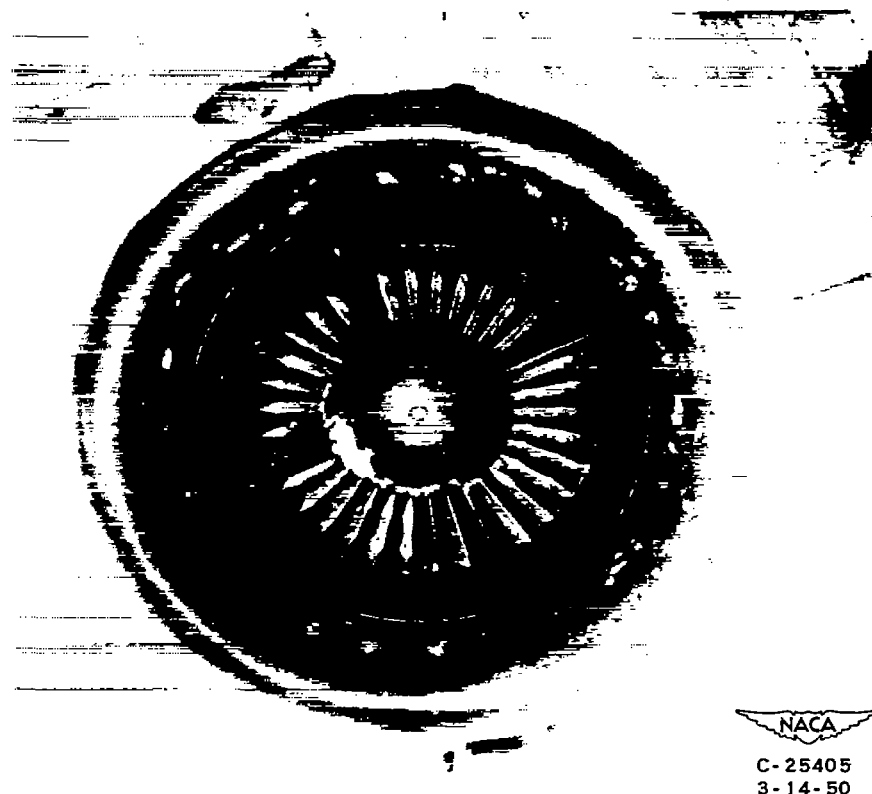
(d) Elapsed time in icing conditions, 35 minutes.

Figure 7. - Concluded. Ice formation on compressor-inlet guide vanes during flight 2, with anti-icing. Liquid-water content, 0.3 to 0.5 gram per cubic meter; droplet size, 11 to 17 microns; ambient-air temperature, 22° to 25° F; thrust loss, 8 percent.

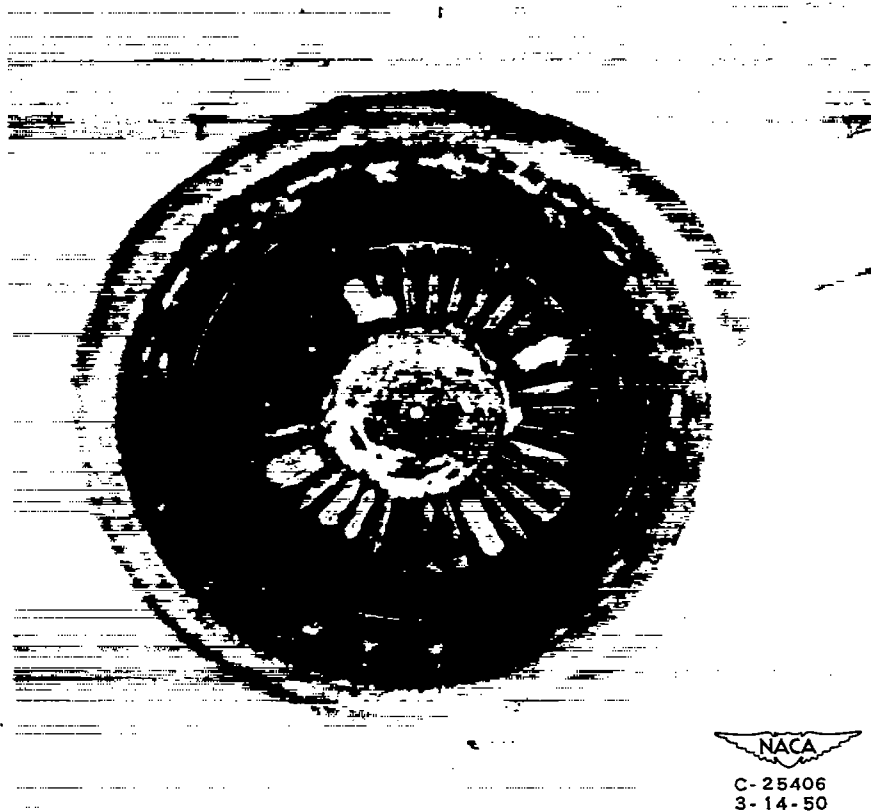
(a) Elapsed time in icing conditions, 5 minutes.

Photographs taken during the second part of the flight (fig. 8) show the progress of the ice formations on the entire engine inlet, when no heating was applied to any of the components. The guide-vane ice formations were similar to those of the first part of the flight. These formations, which appeared to be clear ice built-up, became unstable and broke off in a continuing cycle. This cycle of forming and shedding occurred several times during both parts of flight 2, and was characteristic of all flights in the investigation. After 15 minutes of the second part of the flight had elapsed, however, the formations on the inlet lip and the starter dome became large and the guide-vane formations appeared to stabilize. A large quantity of the water droplets was probably separated out of the air stream by the large crater-like formations on the inlet lip and the starter dome and collected on these formations ahead of the guide vanes.

Figure 8. - Ice formation on turbojet-engine inlet during flight 2, without anti-icing. Liquid-water content, 0.1 to 0.5 gram per cubic meter; droplet size, 11 to 20 microns; ambient-air temperature, 22° to 26° F; thrust loss, 13 to 16 percent.

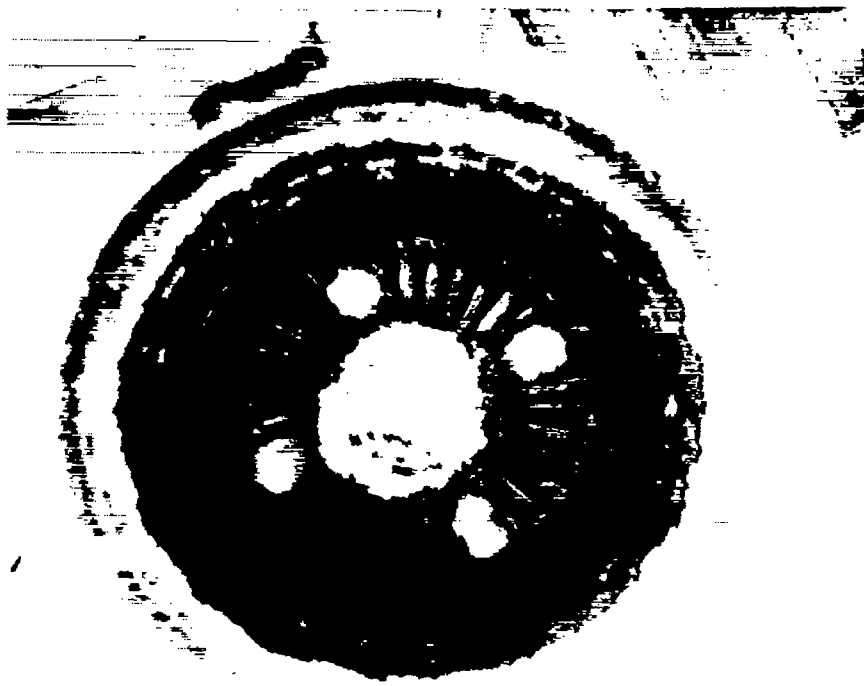
(b) Elapsed time in icing conditions, 9 minutes.

Figure 8. - Continued. Ice formation on turbojet-engine inlet during flight 2, without anti-icing. Liquid-water content, 0.1 to 0.5 gram per cubic meter; droplet size, 11 to 20 microns; ambient-air temperature, 22° to 26° F; thrust loss, 13 to 16 percent.

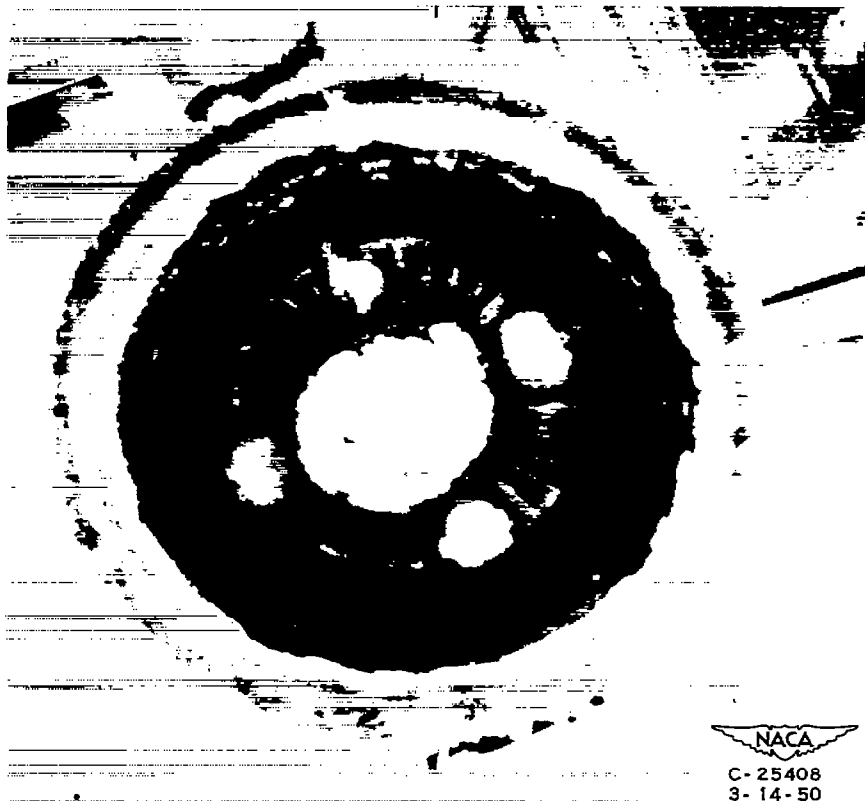
(c) Elapsed time in icing conditions, 15 minutes.

Figure 8. - Continued. Ice formation on turbojet-engine inlet during flight 2, without anti-icing. Liquid-water content, 0.1 to 0.5 gram per cubic meter; droplet size, 11 to 20 microns; ambient-air temperature, 22° to 26° F; thrust loss, 13 to 16 percent.

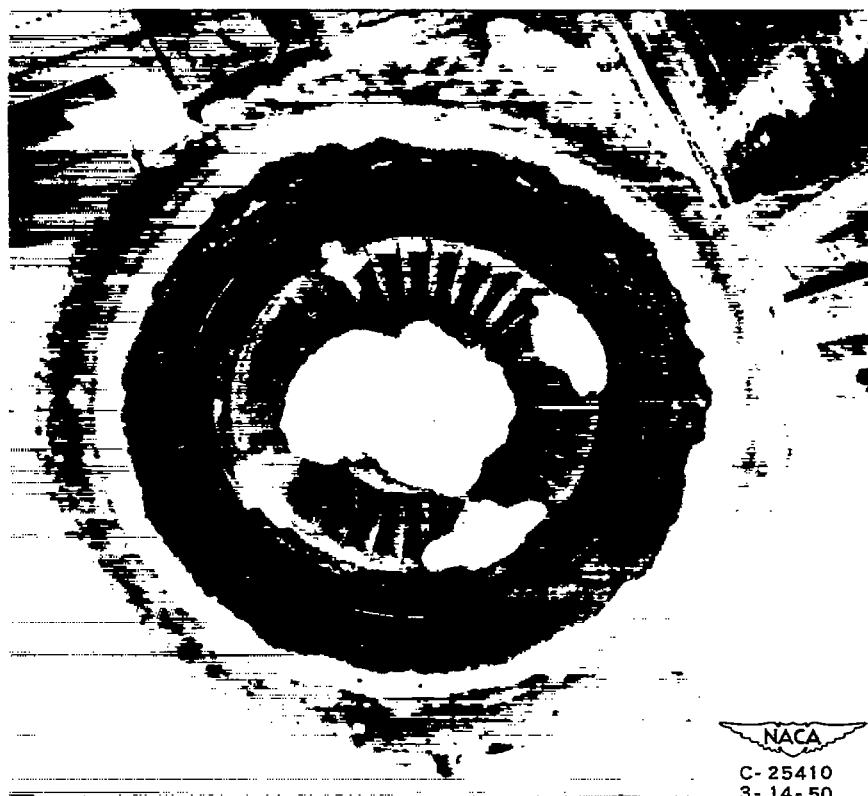
(e) Elapsed time in icing conditions, 39 minutes.

Figure 8. - Continued. Ice formation on turbojet-engine inlet during flight 2, without anti-icing. Liquid-water content, 0.1 to 0.5 gram per cubic meter; droplet size, 11 to 20 microns; ambient-air temperature, 22° to 26° F; thrust loss, 13 to 16 percent.

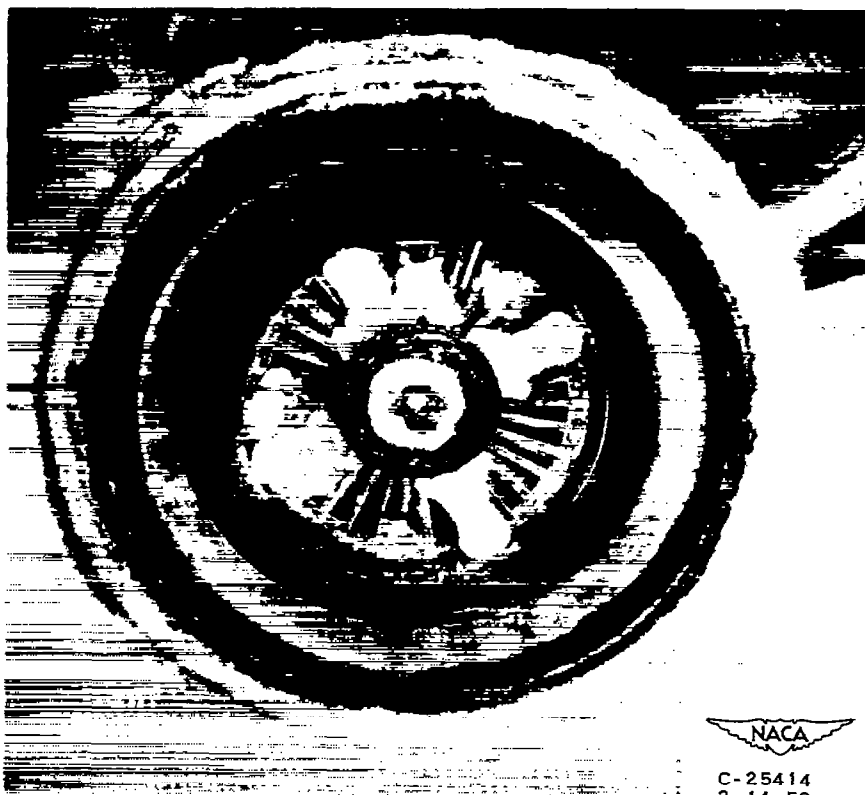
(a) Elapsed time in icing conditions, 70 minutes.

The reduction in engine thrust and the increase in tail-pipe temperature that occurred during flight 3 are understandable from examination of the large ice accretions on the front-bearing support struts and the large loose pieces lodged on the inlet guide vanes, as shown in figure 10(a). Ice formations can be observed on the first-stage stator blades of the compressor. Further penetration of ice formations in the compressor are not detectable. Soon after the photograph in figure 10(a) was taken, the large ice formations shown began to break up and pass through the engine. A photograph taken 6 minutes later (fig. 10(b)) shows that a large portion of the ice formation had disappeared. The result was an increase in engine thrust and a decrease in tail-pipe temperature of approximately 50° F (fig. 9).

Figure 10. - Ice formation on turbojet-engine inlet during flight 3 at 92-percent rated speed. Liquid-water content, 0.4 to 0.9 gram per cubic meter; droplet size, 12 to 14 microns; ambient-air temperature, 17° to 22° F; thrust loss, 26 percent.
